**The Naumann House at the Browning Ranch:  
Historic Structure Report and Proposal for Rehabilitation**

Professional Report

The University of Texas at Austin

December, 2004

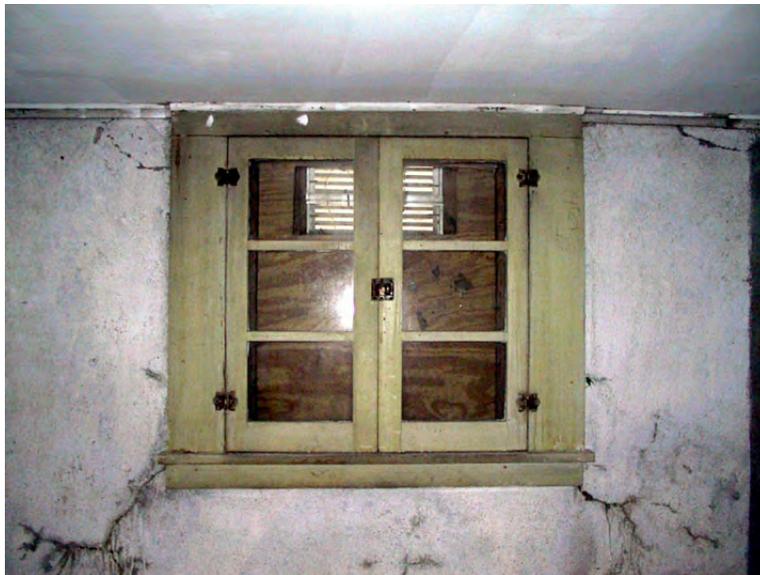
that face west have been partially filled in with concrete on the exterior, but the windows are still operational and are otherwise intact. On the exterior, these windows are covered by wood siding above where the concrete has been poured. There is a metal vent on each. The siding and vents are deteriorated and broken, and some siding is missing on the left one. Where the siding is missing, the original window is visible behind. One window, on the east side, is essentially unaltered, though there is a broken pane and some damage to the opening on the exterior. This window has not been filled in like the others, although it is a state of disrepair. This window is missing a pane of glass, and there is vegetation growing in this opening.

Figure 2.5 Basement window, west wall. (Photo by the author)

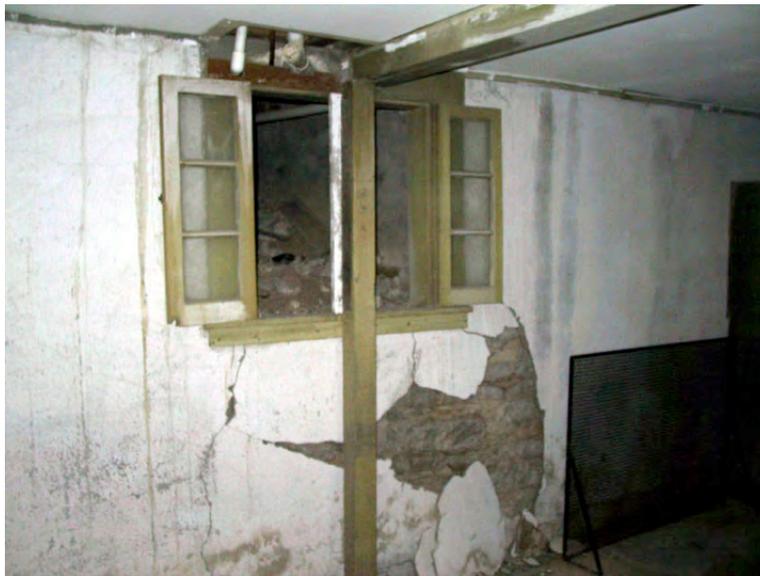
cavity out the window and into the basement ceiling (there is a bathroom near this juncture on the main floor). A wooden column has been placed in front of the window. The window was apparently designed to accommodate a column in this awkward location; its doors neatly accommodate the wooden member and close on either side of it. The window frame does not appear to have been rebuilt in order to accommodate the column; its appearance is comparable in aging and design to the other windows in the room.

Figure 2.6 South basement window and masonry wall. (Photo by the author)

*Recommendations:* One option would be to remove the slab. If this is done, the removal will reveal the now blocked south basement window. This opening has been compromised more severely than the other openings, with its conversion into a crawlspace occupied by pipes. The ground around the house and this newly-revealed window should be landscaped appropriately.

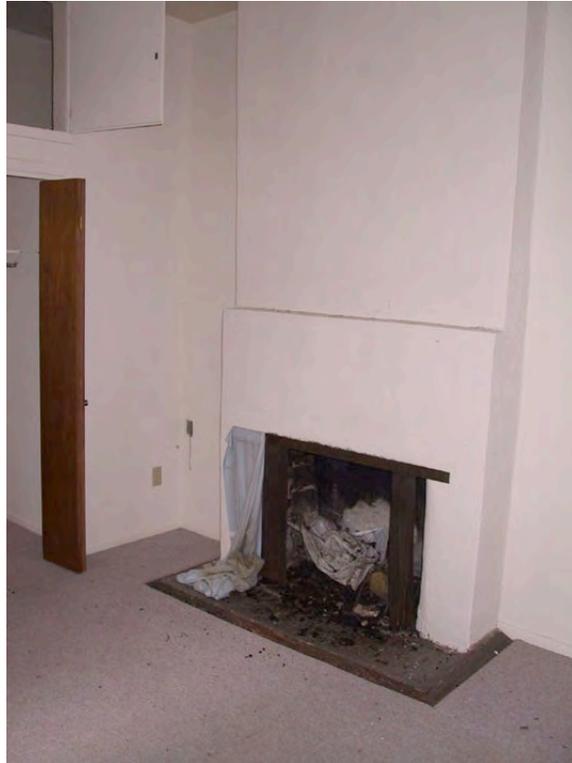
bedroom side, there is a shallow fireplace with a shallow built-in mantel. The flue is narrow and dirty; tension rods are visible within the flue.

Figure 2.8 Fireplace in front bedroom. (Photo by the author)

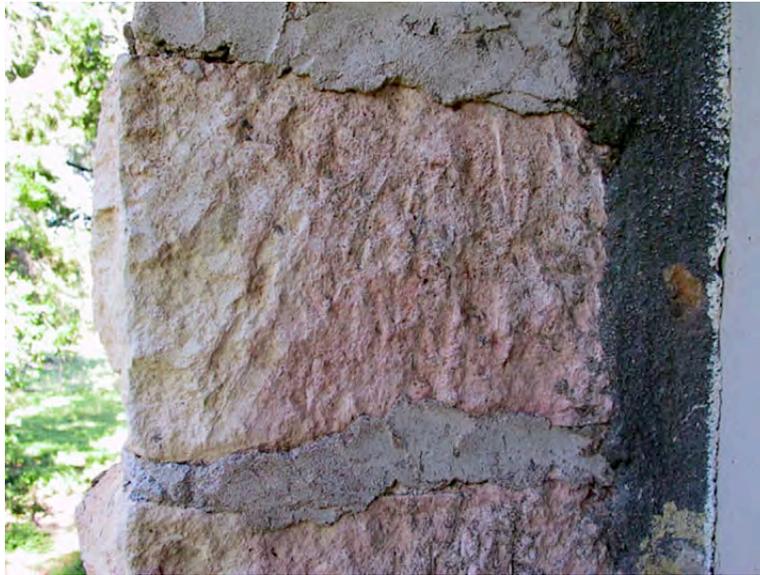
some visible evidence of the fire in the remains of the original building. Many of the limestone blocks have pinkish discoloration around openings, which suggests the leaching of iron oxides as a result of high temperatures<sup>4</sup>.

Figure 3.1 Stone near window showing discoloration from iron oxides. (Photo by the author)

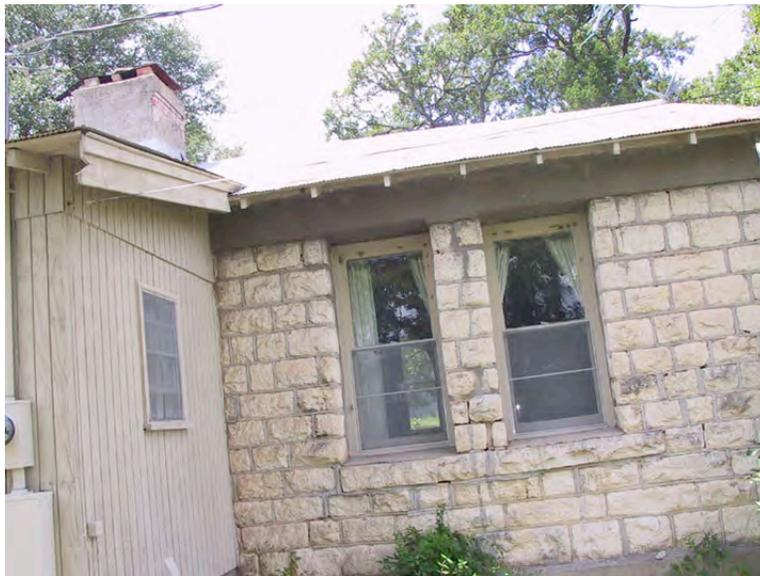
Although the addition doubles the footprint of the house and is integrated into the whole of the interior, it lacks historic merit. This project proposes that removal of the addition is a priority; for this reason, any repairs to the addition are of no consequence. Thus while the addition has several issues, including moisture infiltration (leading to some mold) in some ceilings, the condition of the addition will not be discussed.

Figure 5.1 Original building and addition; northeast corner (Photo by the author)

*Recommendations:* The addition should be removed. This is the single-most important thing that can be done to restore the house's historic character. From the exterior perspective, the original masonry walls and front porch are the most character-defining historic features of the house and should stand alone as the only exterior walls. Removal of the addition will restore the historic exterior

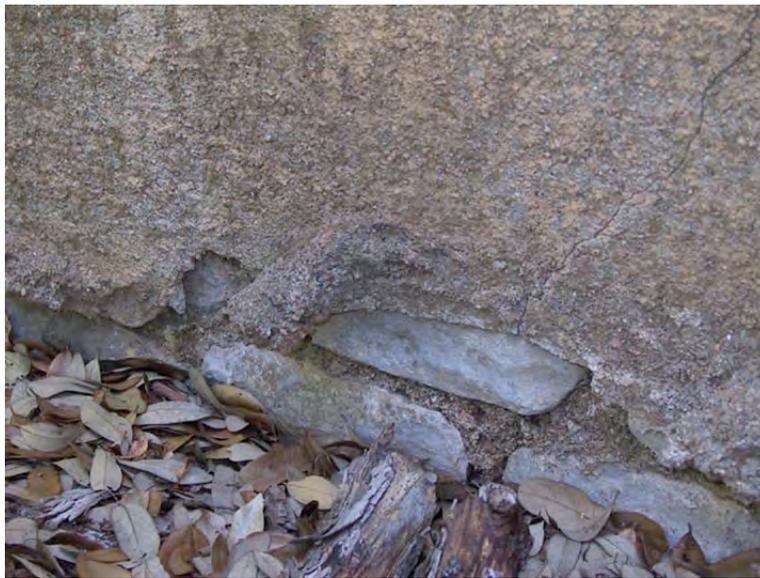
containing a basement. A portion of the foundation is in full view around the exterior (and interior) of the visible portion of the original house. Its condition is less clear when it comes into contact with the addition and the slab foundation for that portion of the house. Although water infiltration has damaged the wall finish and floor in the basement, the stone wall itself appears to be basically sound (although there has been some mortar loss). The foundation of the addition is concrete with a slightly textured finish. Both foundations appear to be sound, with no significant differential settlement. However, the stucco that covers the original exterior masonry foundation is cracking in some places. This appears to be a result of moisture infiltration over a long period of time.

Figure 5.2 Foundation wall; near northwest corner. (Photo by the author)

*Recommendations:* See above with regard to removal of the addition and consequences for the slab. Replace the stucco where needed, matching existing with respect to color, texture, thickness and strength. When stucco is removed, inspect the masonry for any hidden problems. Please refer to NPS Preservation Brief 22, “The Preservation and Repair of Historic Stucco.”

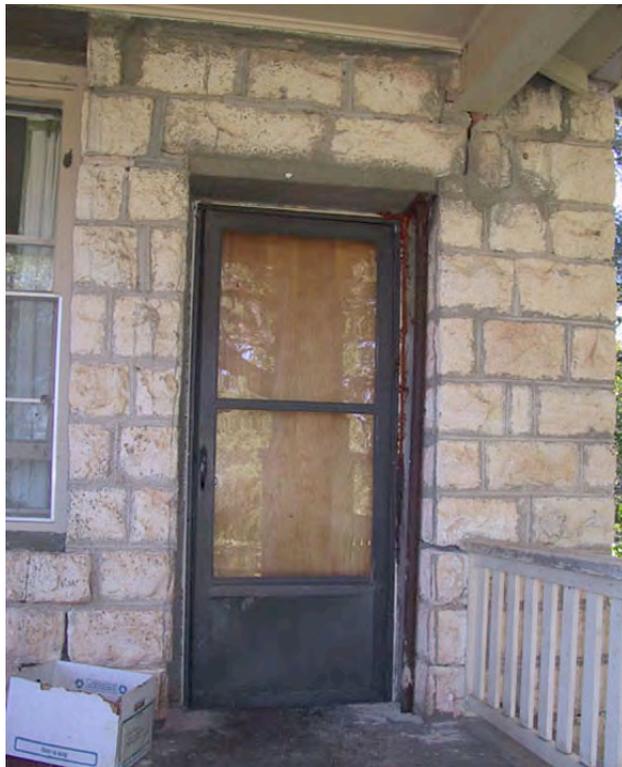
starting at the upper-right corner of the front door. This appears to be a result of strain under the weight of the porch roof.

Figure 5.3 Front door; note crack at upper right corner (Photo by the author)

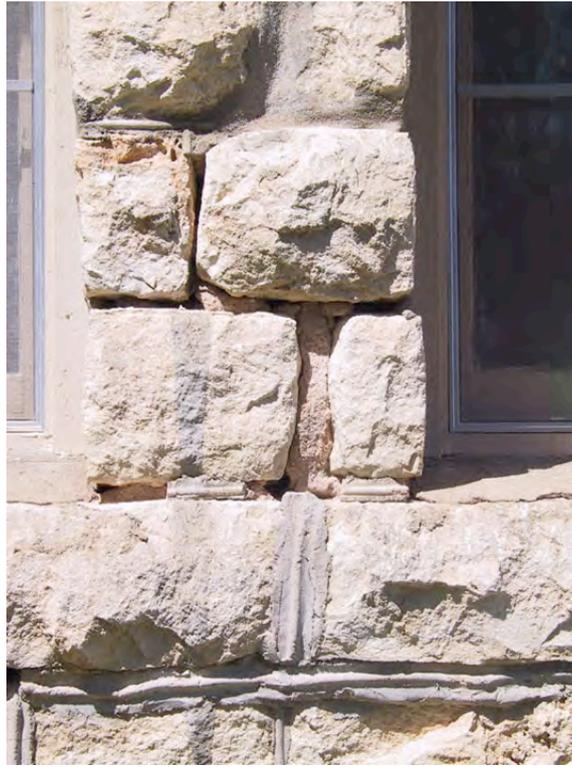
There are several stones with significant cracks in them. These stones include sills and lintels (over the basement windows). There are also several stairstep cracks in the wall accompanied by significant mortar loss. These cracks compromise the structural integrity of the wall and may permit water to enter the wall (though water damage does not seem to be an issue in the wall at this time).

Figure 5.4 Mortar loss and faulty repointing; west façade. (Photo by the author)

There is also an aesthetic issue regarding the mortar repairs that have been done and are still in place. Repointing has been done in a sloppy manner and without taking care to match the original profile of the mortar. In some places far

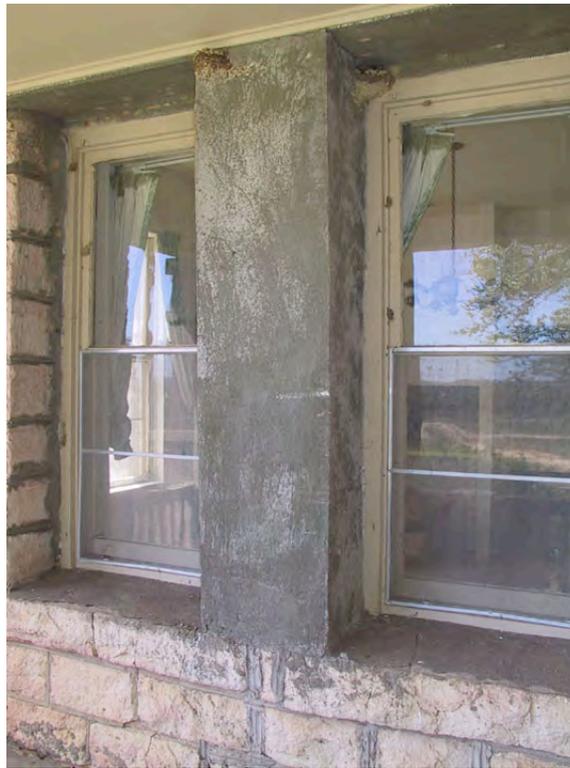
Finally, the column dividing the pair of windows on the north façade has been replaced with concrete from the original limestone. While the original stone may have been damaged, this is neither an aesthetically satisfying solution, nor one that is historically appropriate to the house.

Figure 5.5 Concrete column between windows on north façade. (Photo by the author)

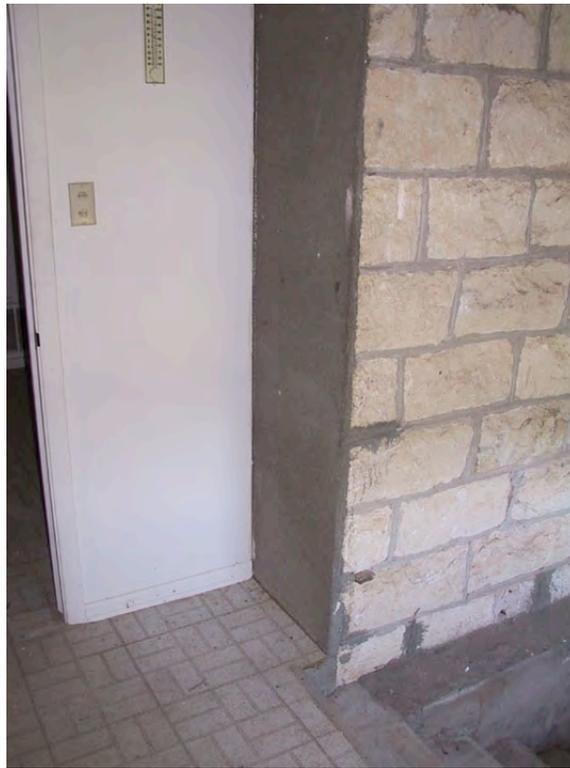
A small section of the original masonry wall is exposed inside the addition, in the side hall. The kitchen window looks out through this wall into this hall. Where this wall turns the corner and is again concealed by gypsum, it is covered by a layer of concrete. The reason for this is not clear – it may have been applied to conceal damaged stone, although no damage is evident in visible material.

Figure 5.6 Corner of wall in stairhall. (Photo by the author)

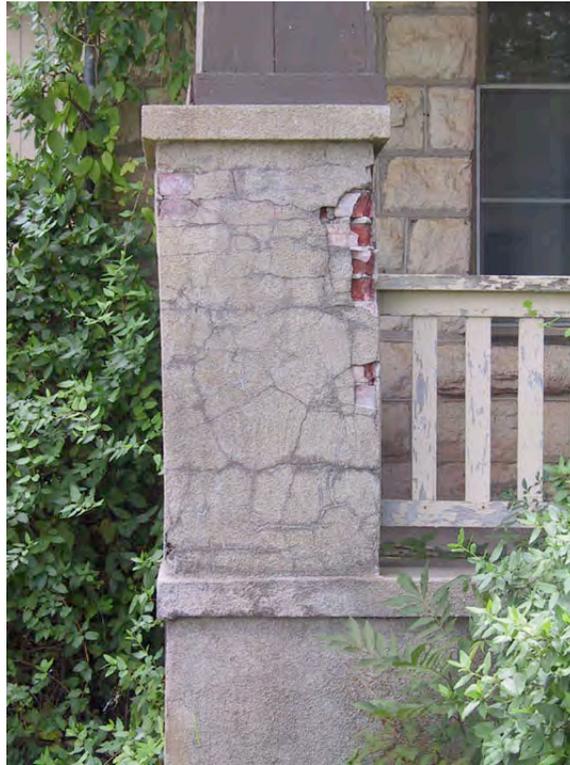
The concrete stucco on each of the piers has been infiltrated by moisture. It is cracked all over, and efflorescence is evident in some places. Pieces of stucco have come free on some corners, in some cases damaging the brick. The piers have also shifted out of plumb. The wooden sections have remained in place, while the brick bases have begun to lean. The piers are leaning away from the building, indicating that they may not be sufficient to support the weight of the porch roof.

Figure 5.7 Northwest pier on front porch. (Photo by the author)

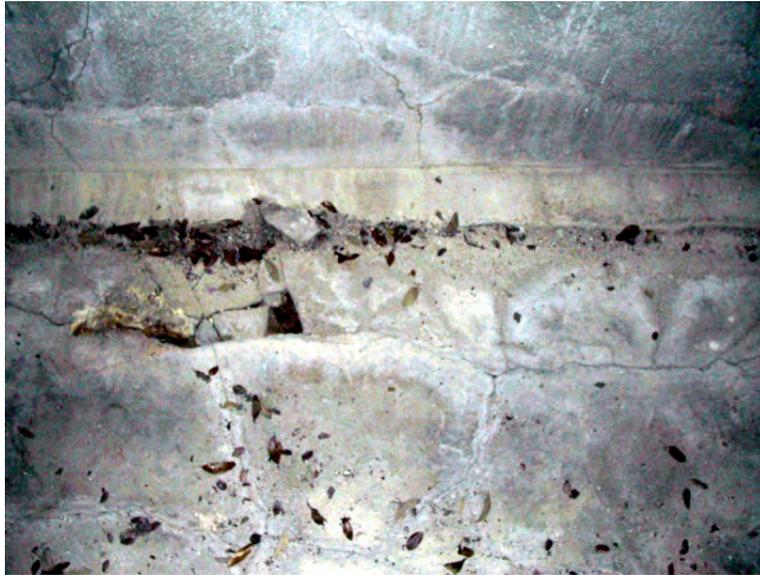
The masonry basement walls do not show evidence of significant movement, and appear to be quite sound. Water infiltration (due to a leaking well uphill from the house) has been extensive in the past, and the basement has been flooded. There is also a pump in the center of the room from this period. The concrete floor slab has been greatly damaged by flooding. The slab is cracked and is breaking up in some places, revealing the dirt beneath.

Figure 5.8 Basement floor and wall; west side (Photo by the author)

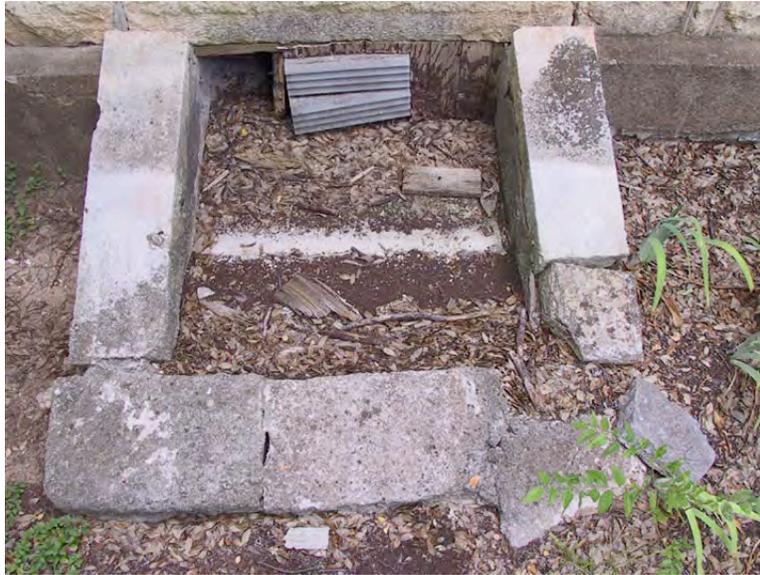
opening. There is a pane of glass missing, and the window frame needs repainting. Finally, many of the exterior stones have been broken into pieces.

Figure 5.9 Exterior of basement window; west façade. (Photo by the author)

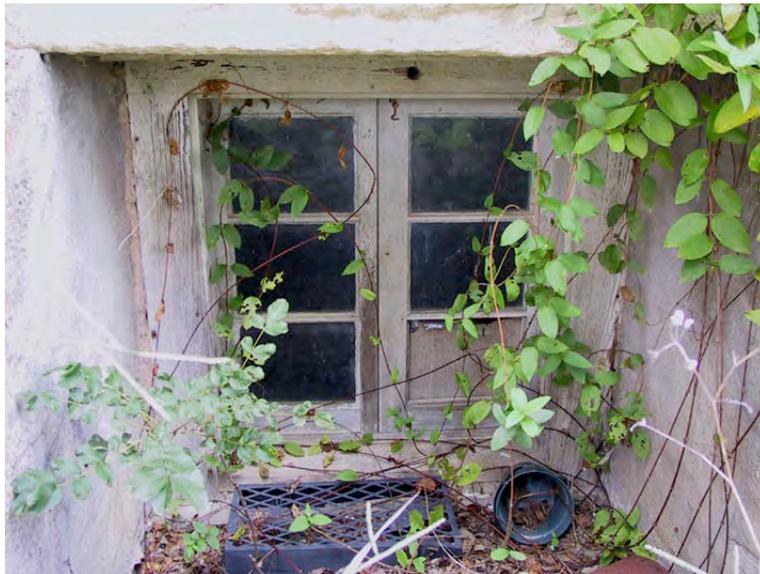
Figure 5.10 Exterior of basement window; east façade (Photo by the author)
