**The Naumann House at the Browning Ranch:  
Historic Structure Report and Proposal for Rehabilitation**

Professional Report

The University of Texas at Austin

December, 2004

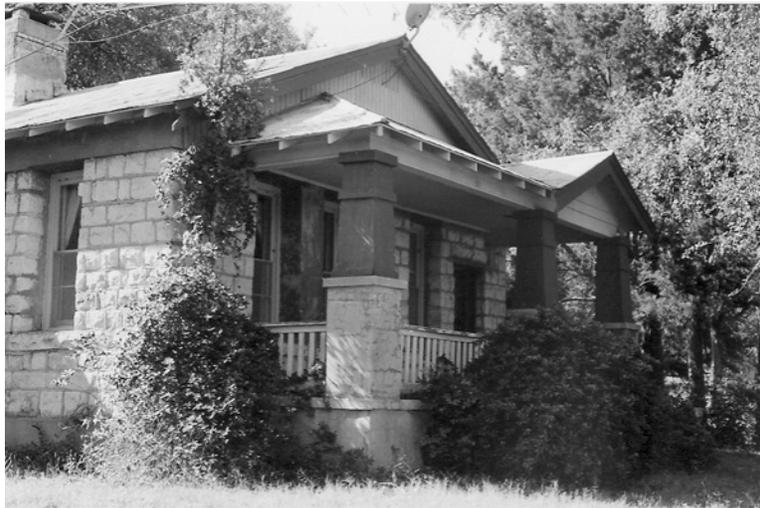
Figure 2.7 Front Porch. (Photo by the author)

stucco. The floor of the porch is a concrete slab scored in six sections. The front steps are stone slabs, but the sides are stone masonry covered by stucco, with a stone slab on top. Three piers support the porch roof. The piers are composed of two parts: the lower, made of brick covered with concrete stucco, and the upper, comprised of a wood envelope concealing an internal means of support. This stucco is cracked all over and in places has disengaged from the brick, revealing the brick.

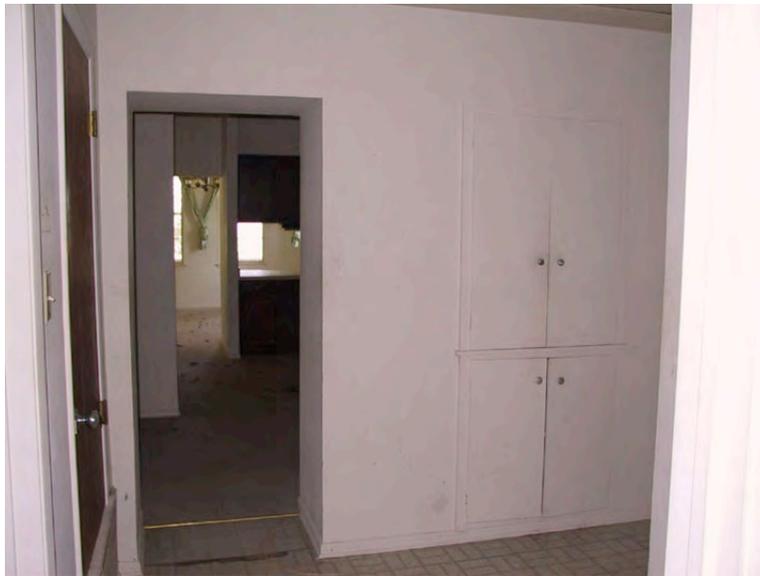
The kitchen and the bedroom each possess two openings on their south side, leading into the backyard. These openings are concealed by gypsum walls and cabinetry now, but they originally consisted of four doors and/or windows, with at least two doors at the center of the ensemble. The presence of the doors further suggests the existence of two separate rooms on either side of the chimney.

Figure 2.14 View from rear hall into kitchen; note passageway and built-in cabinet (concealed original openings). (Photo by the author)

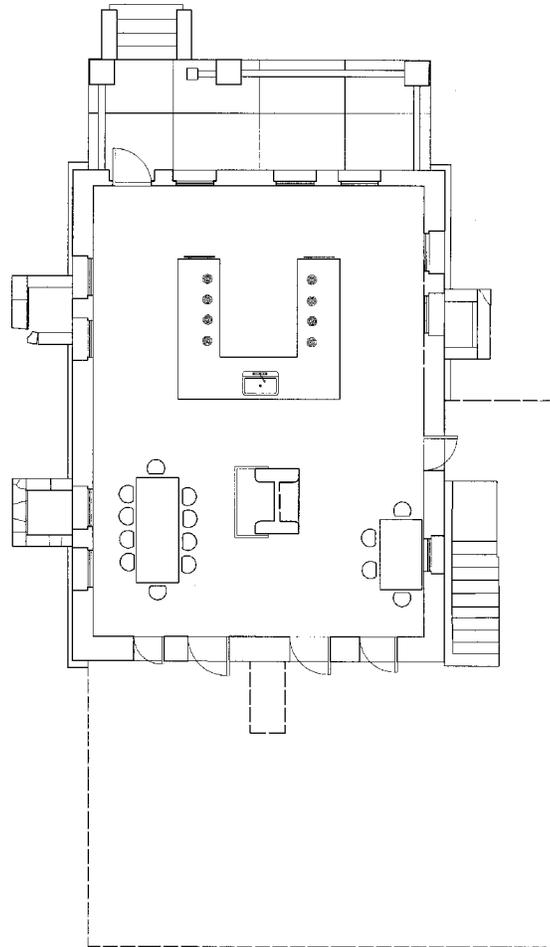
Figure X. Proposed rehabilitation: A possible plan. Note central work island and dotted line showing potential deck. North is at top. (Drawing by the author)
